Heindel and Noyes

RE: Town of Bennington
Willow Road Highway Garage
Bennington, Vermont
Site #96-2041

This letter report summarizes our findings, conclusions, and recommendations following further site investigative activities at the Willow Road Highway Garage site.

TOWN OF BENNINGTON - WILLOW ROAD HIGHWAY GARAGE

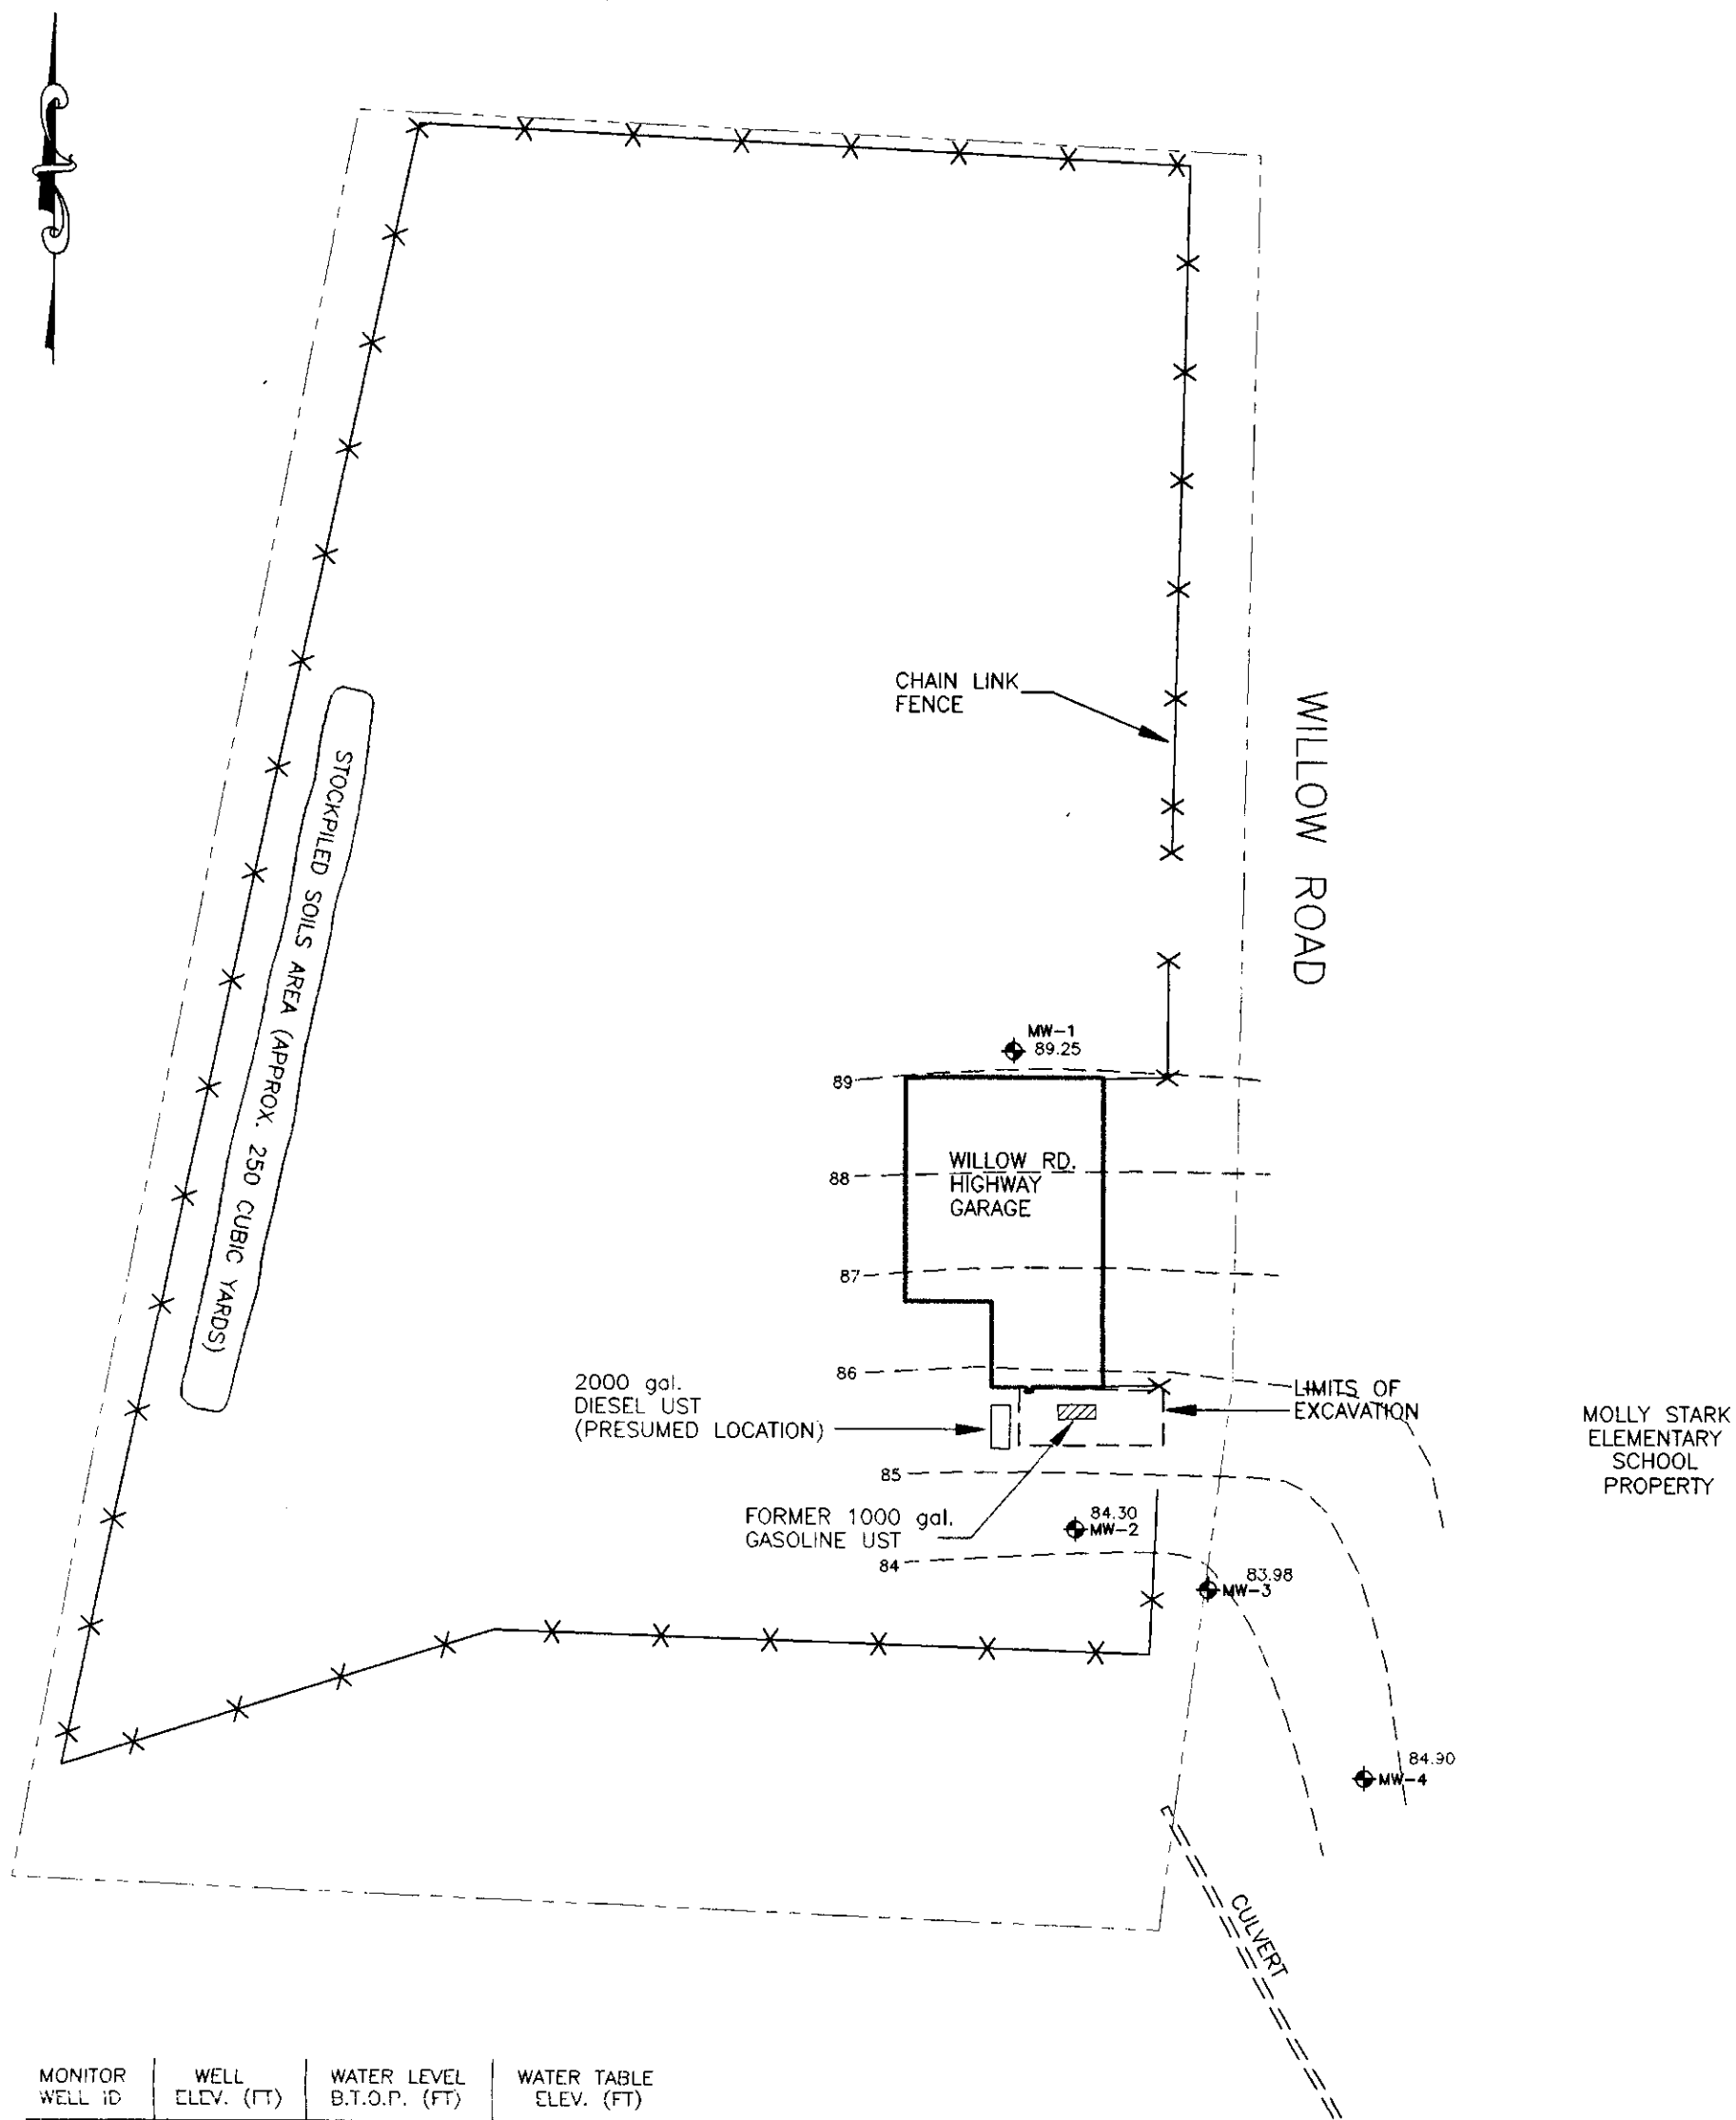
WATER TABLE MAP - JANUARY 23, 1997

On January 23, 1997, eight days after their installation, each well was gauged, checked for petroleum odors or sheens, then purged and sampled. No sheens or petroleum odors were noted in any of the wells. Water level information, coupled to a site survey were used to construct a water table map (Attachment, page 2). Based on our limited data set of four water level points, we observe a groundwater flow direction toward the south in the vicinity of the pulled UST. The gradient of the water table is approximately 4%.

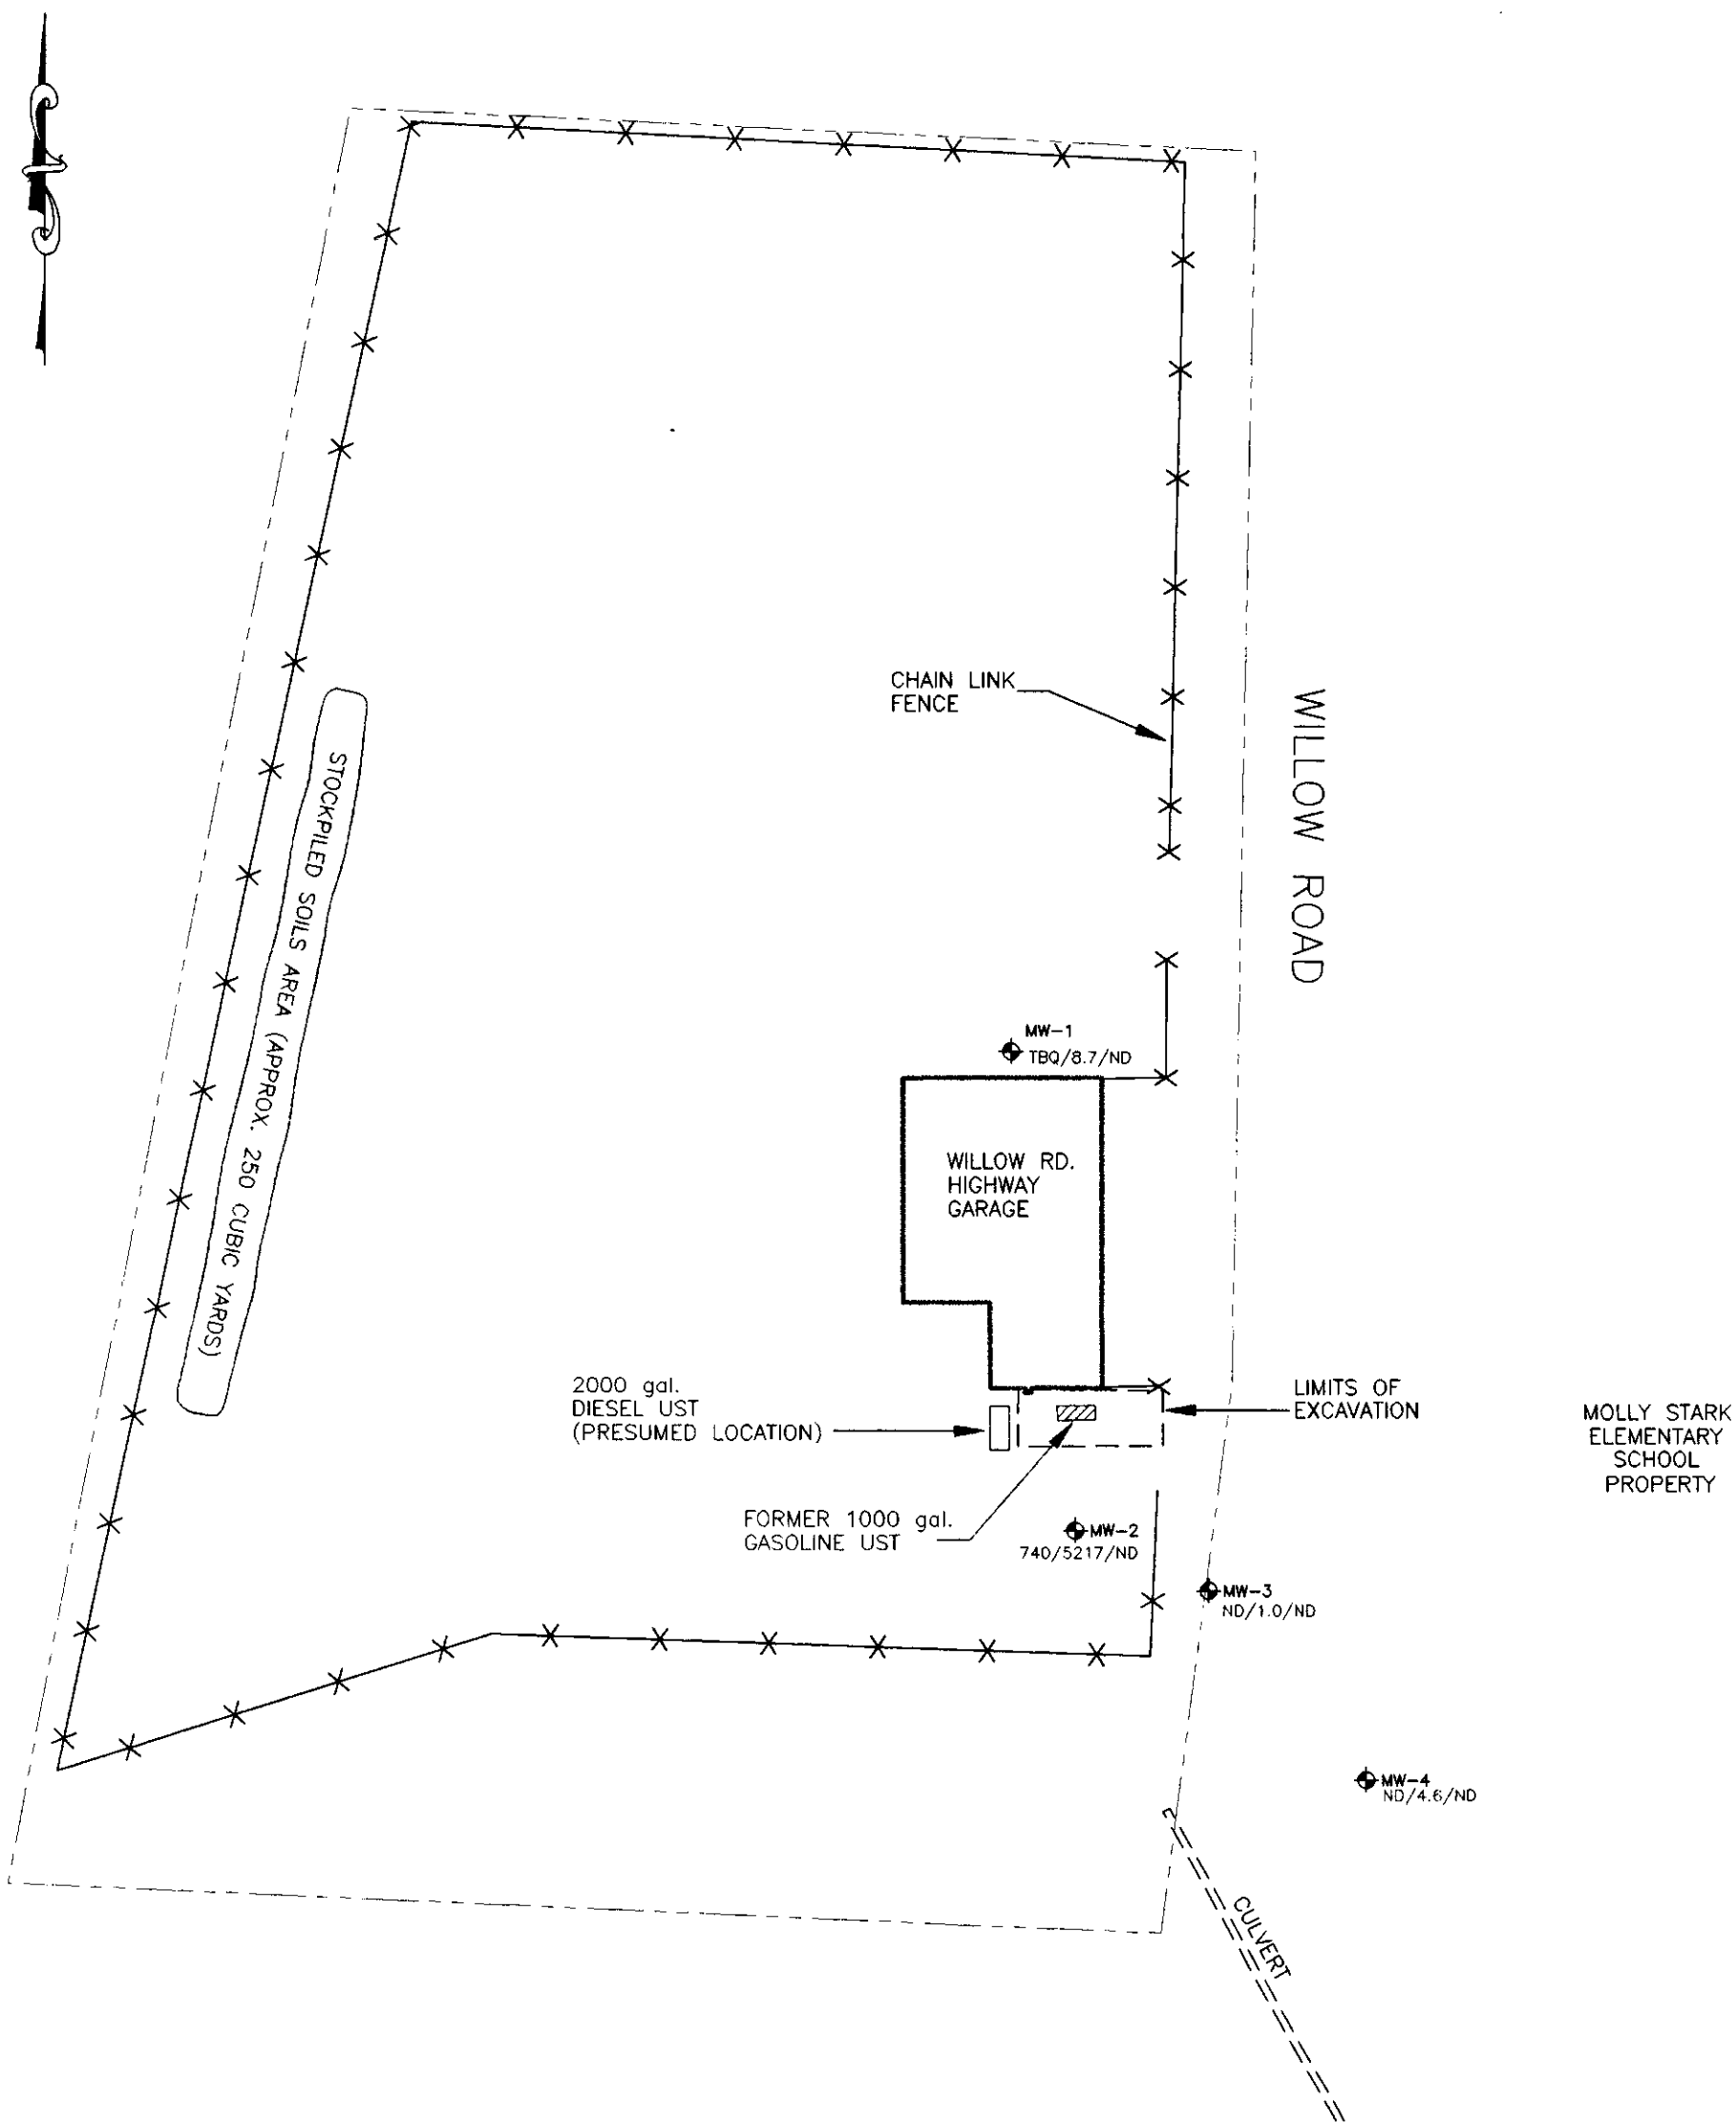
CONTAMINANT DISTRIBUTION MAP (ppb) – JANUARY 23, 1997

As expected from the PID levels in soils, the highest level of groundwater contamination was observed in monitor well MW-2, with a concentration of 740 parts per billion (ppb) benzene, and 5,217 ppb total BTEX (benzene, toluene, ethylbenzene, and xylenes). With the exception of a trace below quantitation level (TBQ) of < 1 ppb in MW-1, no other detectable benzene was observed on the site. Very low levels of other BTEX compounds

were observed in MW-1, MW-3, and MW-4. However, we also observed contamination from benzene (TBQ < 1 ppb), toluene (TBQ < 1 ppb), and xylenes (3.5 ppb) in the trip blank collected for this sampling round. Due to the trip blank contamination, we cannot say with certainty that the contamination observed in MW-1, MW-3, and MW-4 was actually derived from the groundwater, and not introduced into the sample during transport to the laboratory. It is therefore possible that only MW-2 contains any detectable contamination in the study area.

Methyl-tert-butyl-ether (MTBE) was absent from all upgradient and downgradient wells. This additive was first introduced into gasoline in the mid-1980's, so its absence suggests that the release or releases that caused the contamination may have preceded this date. We understand that there were never any other USTs at this location (interview with Roger Cross, Foreman, Willow Rd. Highway Garage on March 11, 1996). It is possible that the holes observed in the pulled tank developed from displacement of pebbles adjacent to the tank during the tank pull and tank cleaning, and that the tank was not leaking. The source of contamination may be from tank overfills or spillage that occurred prior to the mid-1980's. It is also possible that the 2,000 gallon diesel tank still buried at the site is the source of BTEX contamination in MW-2. However, PID levels in soils declined in the gasoline tank excavation toward the west, or toward the diesel tank UST location, so we suspect that this remaining tank is not the source of the contamination.

We recommend an additional round of groundwater quality samples to be collected in July 1997. A sampling round that includes a clean trip blank (which is customary during Heindel and Noyes' sampling trips) will provide some additional information about the presence or lack of contamination in MW-1, MW-3, and MW-4. One additional sample

from MW-2 will also begin to build a database on the temporal variations of BTEX compounds in this well. Future sampling rounds beyond the second sampling round may only require evaluation of MW-2.
